## Inspection Field Notes for Former Plastech-Andover Facility

Facility&Address: Former Plastech Engineered Products, Inc.-Andover  
205 Maple Street Extension  
P.O. Box 459  
Andover, OH 44003  
ID number: OHD068896778  
Inspector: Frank Zingales (FZ)  
Date: 2/11/09  
Time: 1000-1140  
Facility Rep: Laurie Frederick (LF)  
Cell phone: (440) 344-0265  
E-mail: bucshell@email.com  
Purpose of Inspection: Compliance evaluation inspection  
Sample(s) Taken: No  
Photograph(s) Taken: Yes

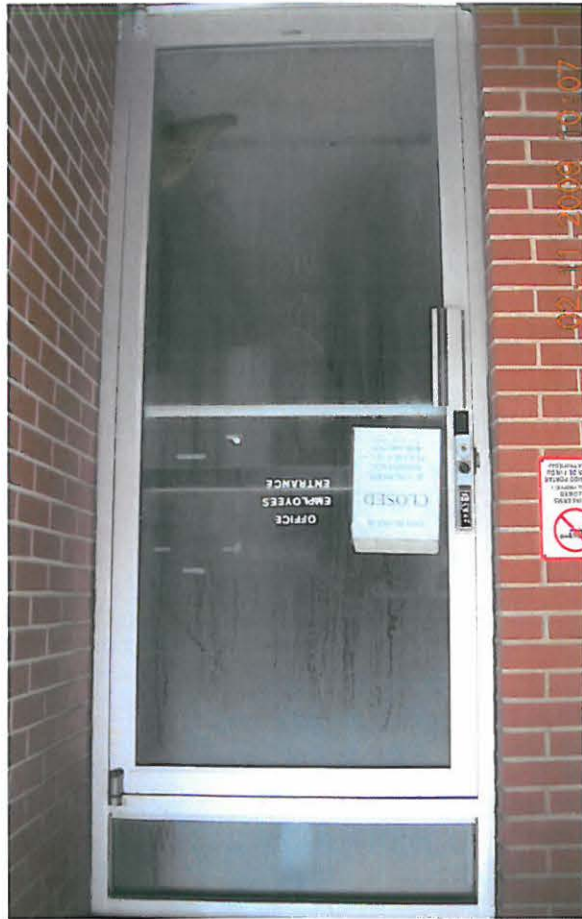
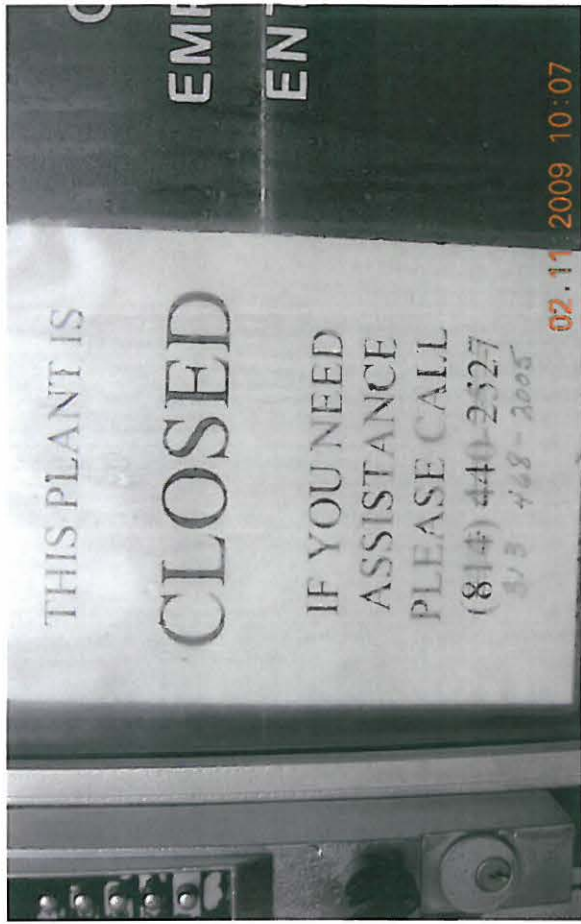
Arrived on-site and inspected exterior areas of facility-north and west sides. North side-equipment present in Quonset Hut on; no containerized wastes observed. West side-on door leading to office area: This plant is closed. If you need assistance please call 313-468-2005.

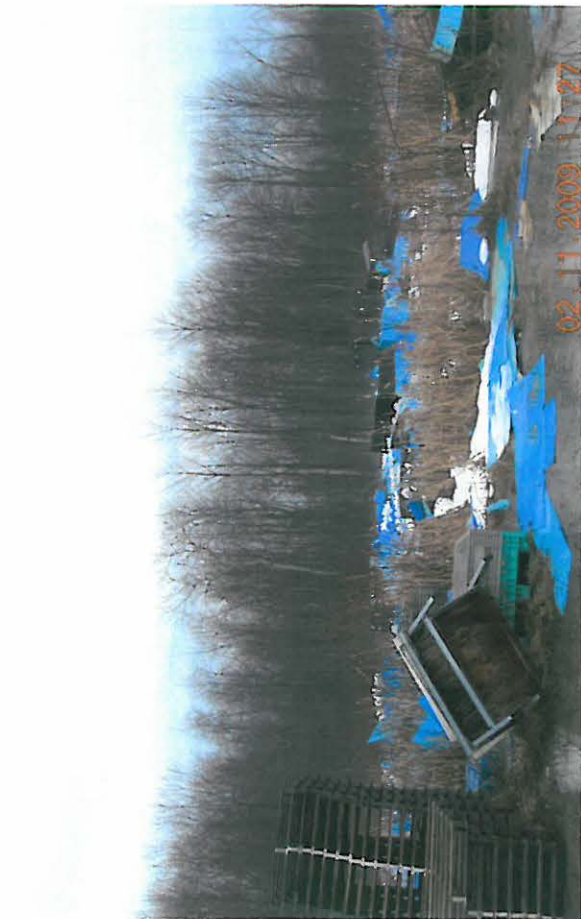
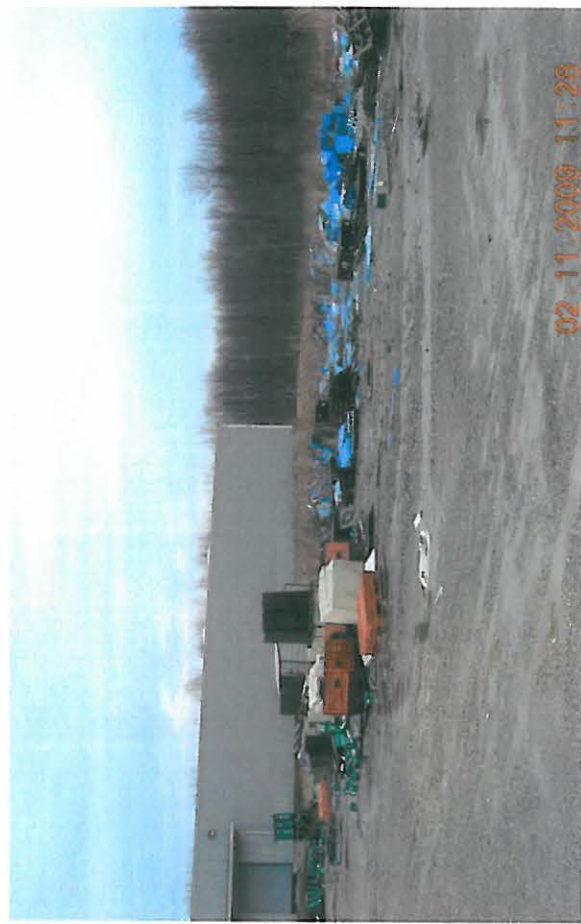
Southeast corner/South side of property-wood pallets and plastic packaging present.
